MOUNT GREYLOCK STATE RESERVATION  
LANESBOROUGH, MASSACHUSETTS

23 June 2007

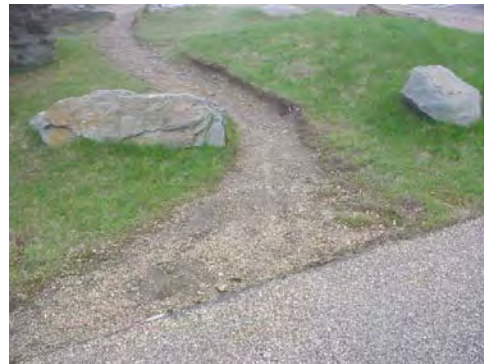
Figure 2. Wear paths

- Wear paths should be established as paved pathways OR re-seeded and barricaded using natural stone barriers while the turf matures.

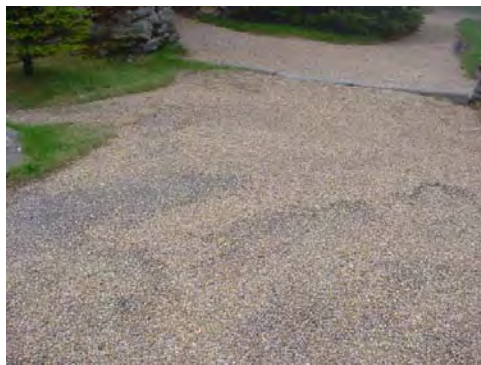
Figure 5. Chip seal paving.

The site is in fair condition. Pathways around the building are paved with a chip seal. Surface drainage has eroded the chip seal, exposing the asphalt paving beneath (Figure 5). Surface drainage has also eroded site materials, especially on the south side of the lodge and along the edges of the pathways (Figure 6 & 8).

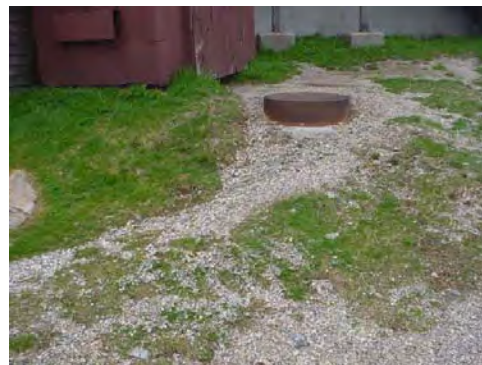
Figure 6. Site drainage.

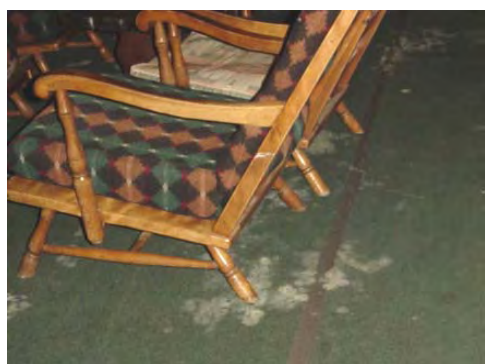
Figure 14. Mold growth.

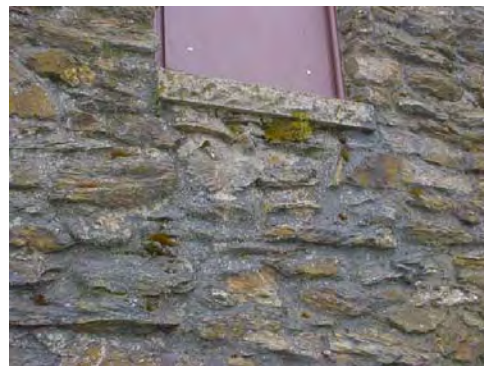
Figure 23. Stone window sill.

The locally quarried stone walls are laid in a random pattern with wide mortar joints. The majority of the stone walls have tight uncracked mortar joints. Mosses and lichens have developed on the walls (Figure 22). There are some noticable cracks on the north elevation beneath the stone sills (Figure 23) and beneath the wood bracket (Figure 24).

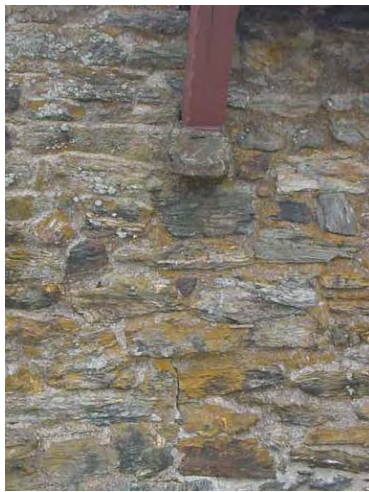
Figure 24. Mortar crack.

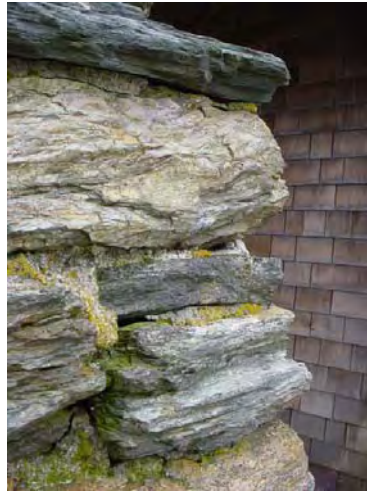
There is missing mortar on the pier supporting the arch on the west elevation (Figure 25). There is also a radial crack in the arch as a result of unbalanced and weak bearing points. The pier and crack should be patched and repointed.

Figure 25. Missing mortar.

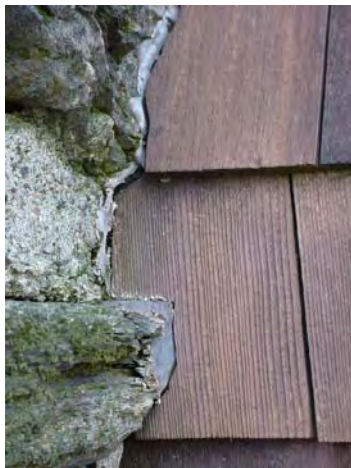
Figure 26. Failing sealant.

The junction of the stone and wood walls has been sealed in recent years with a clear bead of sealant (Figure 26). The sealant has failed in areas of extreme exposure. The joints should be cleaned and resealed. Sealant should be routinely monitored and replaced when necessary.

- Routinely monitor sealant and replace when necessary.

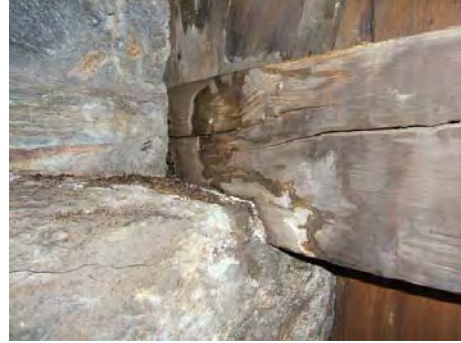
Figure 31. Deteriorated end wall truss.

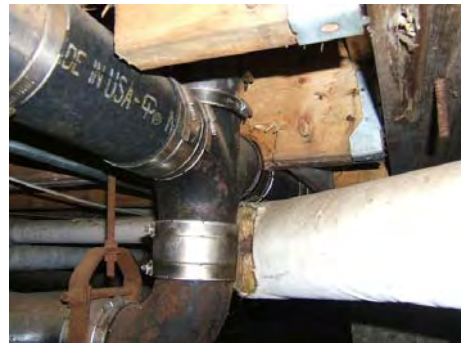
Figure 33. Notched framing.

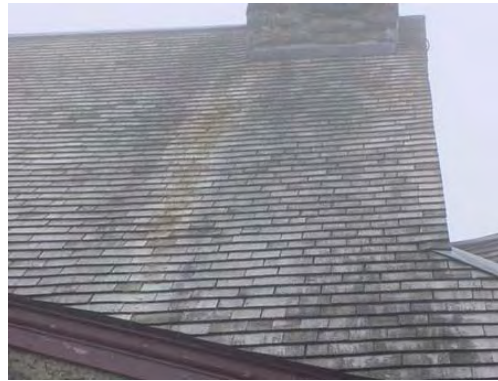
Figure 35. Stained wood shingles.

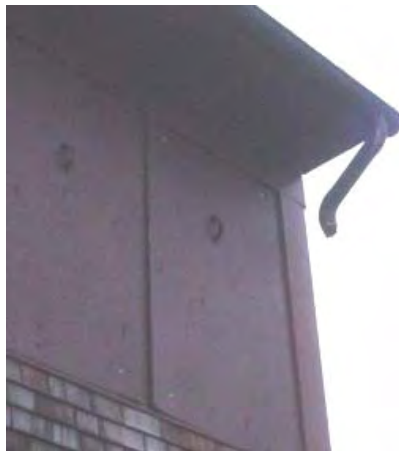
Figure 36. Missing downspout

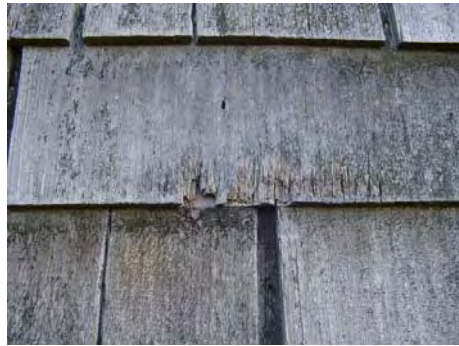
Figure 40. Deteriorated wood shingles.

- Provide new exterior wood shingles. Provide airspace behind shingles to facilitate drying.

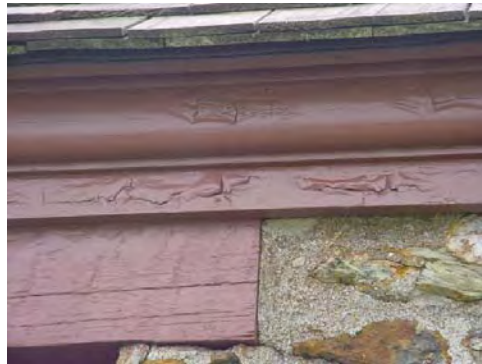
Figure 42. Peeling paint.

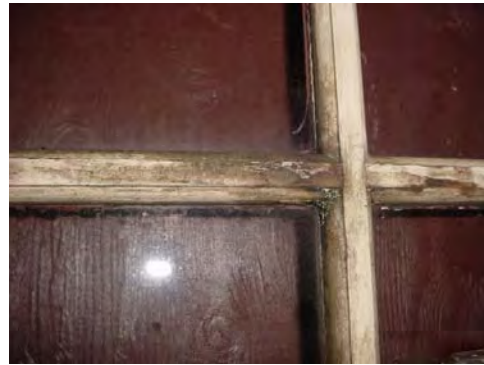
Figure 54. Mildew on dormer window.

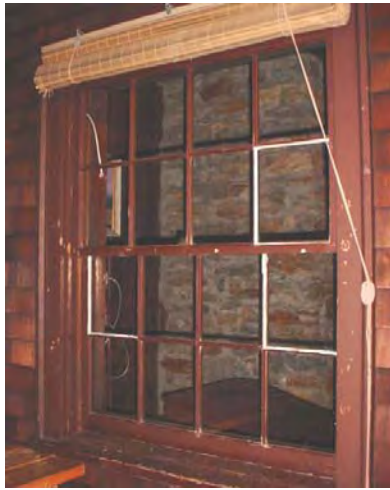
Figure 55. Broken ropes and replacement glass.

The windows are all visible from the interior. There are a few original windows on the first floor, primarily in the main gathering hall. The remaining windows appear to be replacement windows with plastic sash liners and wide muntins (Figure 54). The windows are in fair condition, needing only minor repairs and a good cleaning. There are several cracked window panes, mold growth, some missing or broken hardware (Figure 55), and missing muntins (Figure 56).

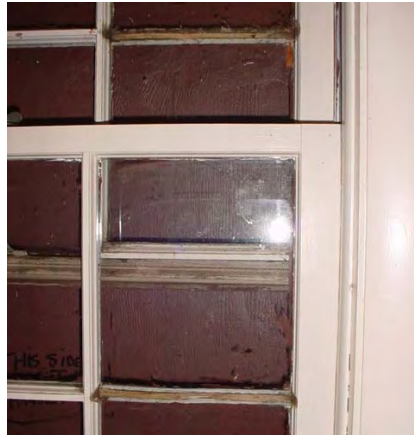
Figure 56. Missing muntins.

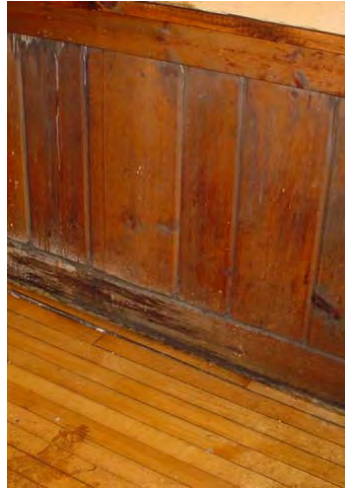
Figure 64. Damaged paneling.

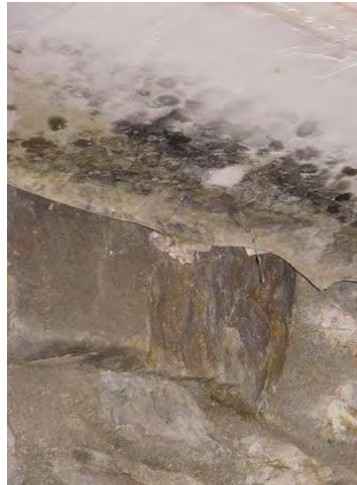
Figure 66. Damage from leak.

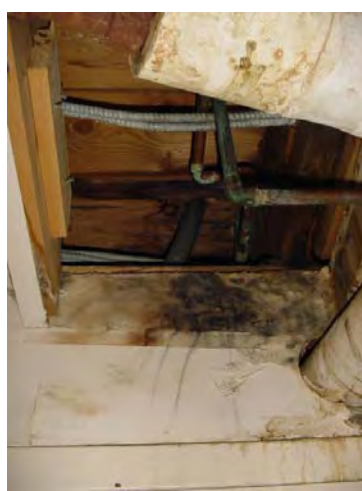
Figure 72. Moldy drywall in basement.

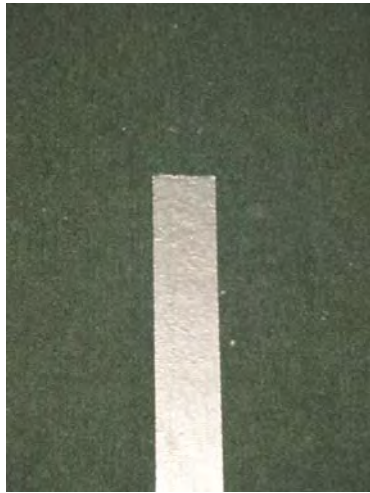
Figure 75. Duct tape repair to carpet.
